Common Causes of Cylinder Head Gasket Failures

The AERA Technical Committee offers the following information regarding common causes of cylinder head gasket failures. AERA members often encounter blown head gaskets and would benefit from understanding why the gasket failed before doing a repair. Physical examination of the failed head gaskets can provide a clue as to the root cause.

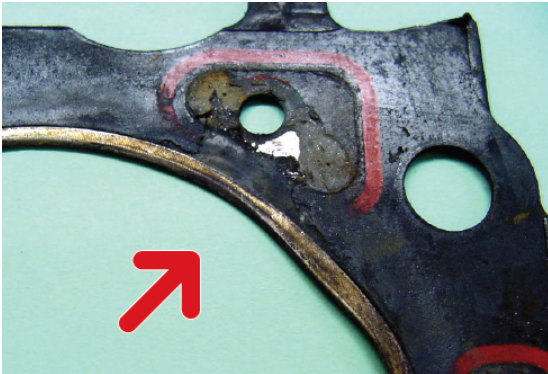
Figure 1: Detonation has distorted the combustion seal and gases escape into the cooling system.

Detonation and Preignition occur when there is an abnormal combustion event. The air-fuel mixture spontaneously ignites preventing a smooth burn and this collides with the normal flame front producing extreme cylinder pressure. Common causes of detonation and preignition are listed below with explanations.

High Compression	Increased pressure at compression stroke raises temperature of air-fuel mixture, leading to spontaneous combustion.
High Temperature	Elevated engine temperatures from high load, improper cooling or hot spots can trigger spontaneous combustion.
Fuel Octane Rating	Using fuel with too low octane rating can lead to spontaneous combustion.
Improper Tuning	Incorrect ignition timing and lean fuel mixtures or excessive boost can contribute to spontaneous combustion.
Carbon Deposits	Carbon deposits can act as hot spots and ignite combustion.
Spark Plug Issues	Damaged or improperly gapped plugs can cause pre-ignition and lead to detonation.

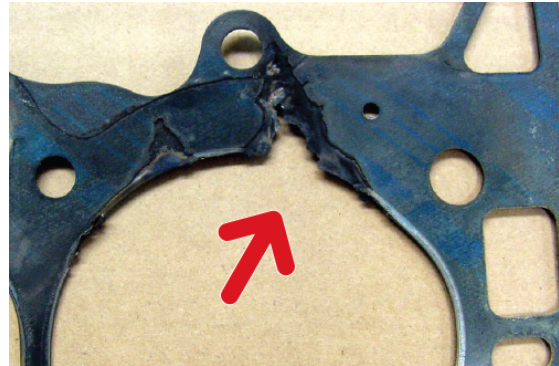
Figure 2: Excessive pressure waves eventually burned through the gasket.

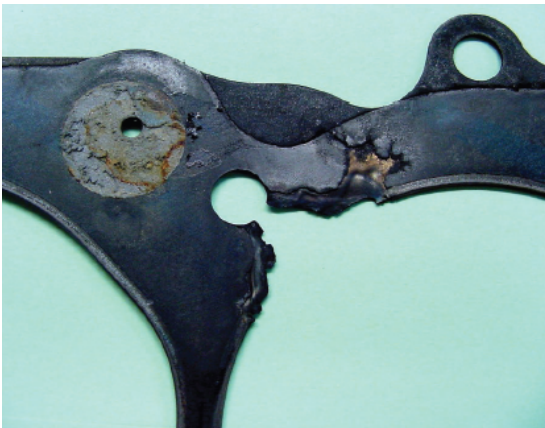
Figure 3: Another example of excessive pressure waves burning through the gasket.

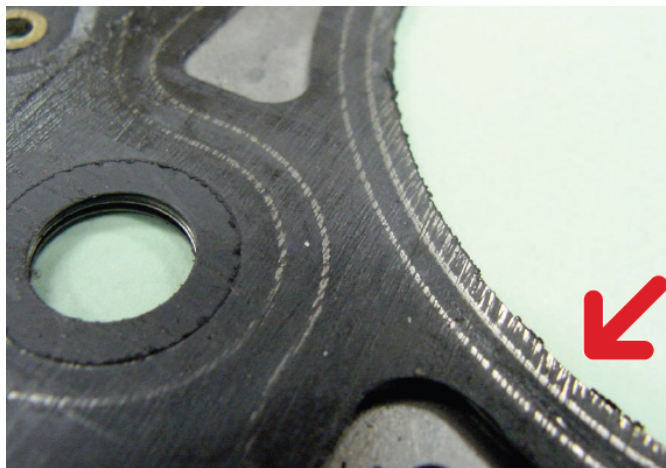
It is recommended to check with the gasket manufacturer for the finish requirements of their gaskets. An example of a head gasket failure due to rough surface finish is shown in Figure 4 below.

Figure 4: Rough surface finish shown – Peaks and Valleys too tall to seal.

Composite gaskets require a rougher surface finish compared to modern MLS gaskets. The roughness of the finish helps bite into the more conformable composite gasket and hold it from shifting in operation. The composite material being more conformable can fill the taller peaks and valleys in the finish to seal fluids. Using a smoother surface finish on a composite gasket will not bite into the gasket to hold it, the gasket can shift in operation, eventually tearing the facing material and lead to leakage. Composite gaskets generally use a surface finish of 60-100 Ra for cast iron heads and 50-60 Ra for aluminum heads.

MLS head gaskets as described earlier use a smoother surface finish due to the thin rubber coating on the outside of the gasket. This coating is .0005-.0010" thick, this thin coating can fill the peaks and valleys of the smoother finish and hold the gasket from shifting in operation. Too smooth a finish can be an issue as the gasket will tend to shift in operation and this movement can wear off the rubber coating leading to a leak. MLS head gaskets generally use a 20-30 Ra if using OE gaskets and up to 60 Ra on some aftermarket head gaskets as the coatings on them are usually thicker.
